SB4/2024

Foundering of the fishing vessel

Argos Georgia

MAIB SAFETY BULLETIN 4/2024

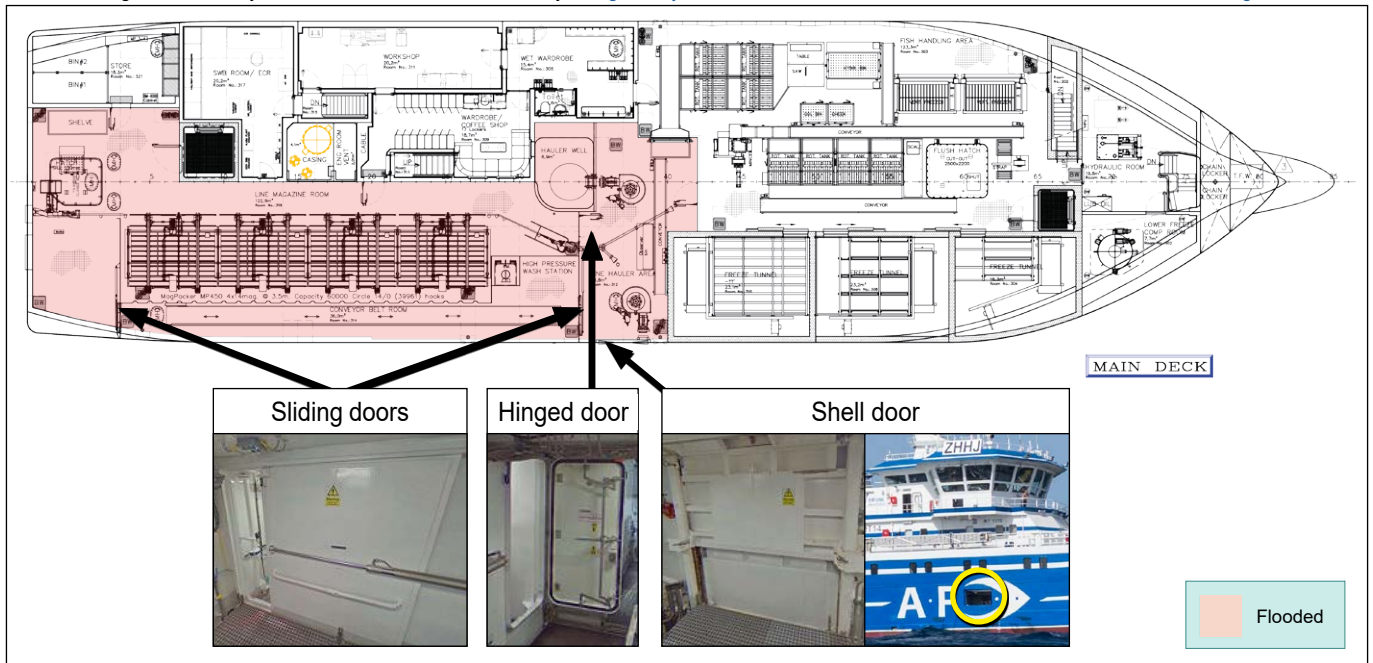
At about 1230¹, in a position approximately 190 nautical miles east of Port Stanley, *Argos Georgia* suffered an uncontrolled ingress of water through the shell door into the hauling compartment on its starboard side. Water then entered other areas aft of the hauling compartment (see **Figure**) and the vessel took on a starboard list. *Argos Georgia* was turned into the weather and the master raised the alarm via a colleague on a fishing vessel operating in the same region. This alarm was relayed to the authorities in the Falkland Islands and a SAR operation initiated using air and sea assets, supported by other fishing vessels.

Figure: Plan of *Argos Georgia* main deck, showing the extent of the initial flooding

The ongoing investigation has found that, before the accident, the shell door in the starboard side of *Argos Georgia* was raised in the closed position. At the time of the accident the door was observed on closed-circuit television to descend slowly into the fully open position. This allowed significant quantities of water to enter the vessel. The crew were unable to close the shell door once it had opened.

Internal doors leading from the hauling compartment were open. This allowed water to flow unhindered into other areas of the vessel, causing a significant list that progressively increased as more water entered. The crew were unable to control the passage of water into other spaces in the vessel, which increased the list still further until the vessel foundered.

S2024/137M Urgently ensure that a suitable and sufficient assessment of the risk of water entering the vessel through a side shell door has been undertaken and documented, noting the safety issues identified in this safety bulletin, and that:

- mitigations identified are immediately implemented to reduce the risks associated with a failure of a shell door;
- where a risk of consequential flooding between compartments exists, appropriate measures including maintaining internal doors in the closed position are taken; and
- the crew are informed of the findings of the risk assessment and the measures taken for their protection.
